# Photos of leak in milled Al-foil; $1.1 \cdot 10^{-6}$ mbar l/s

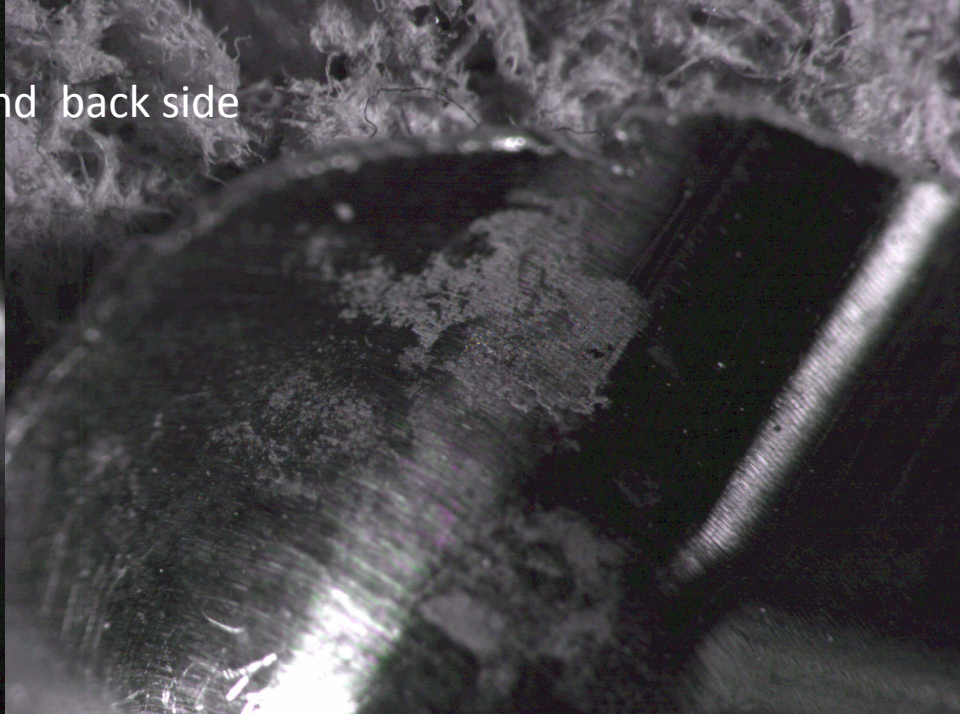
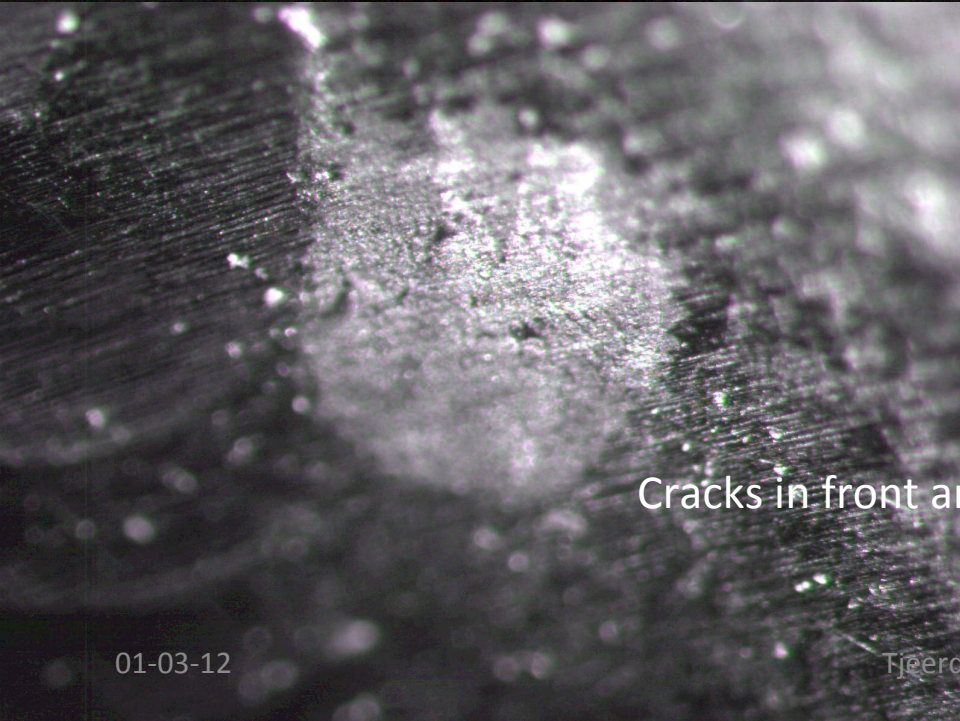
Front and back side

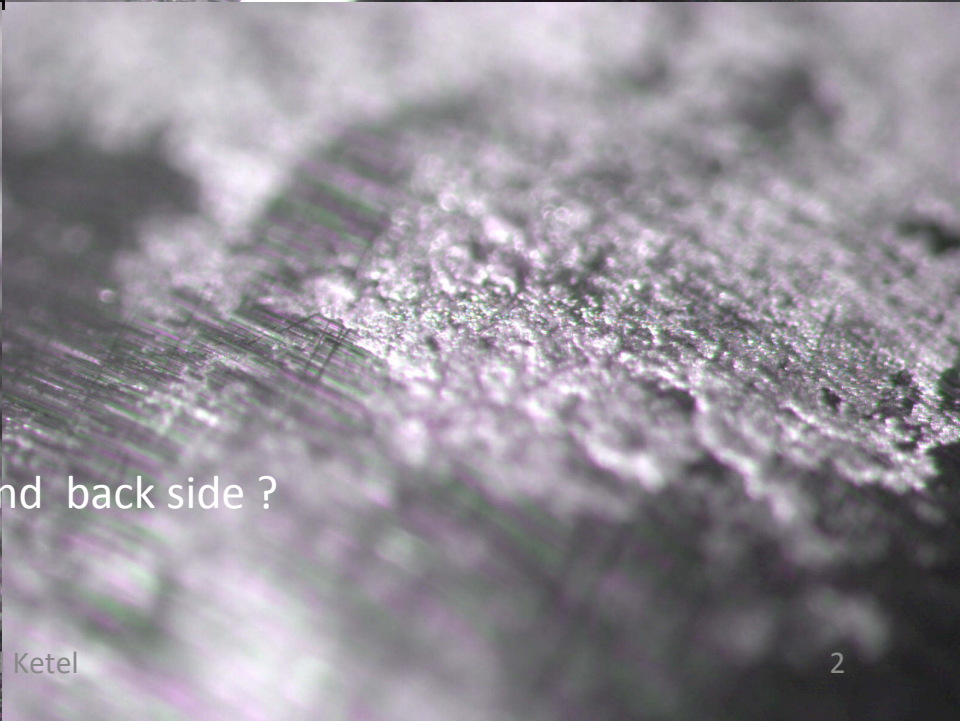
Cracks in front and back side ?

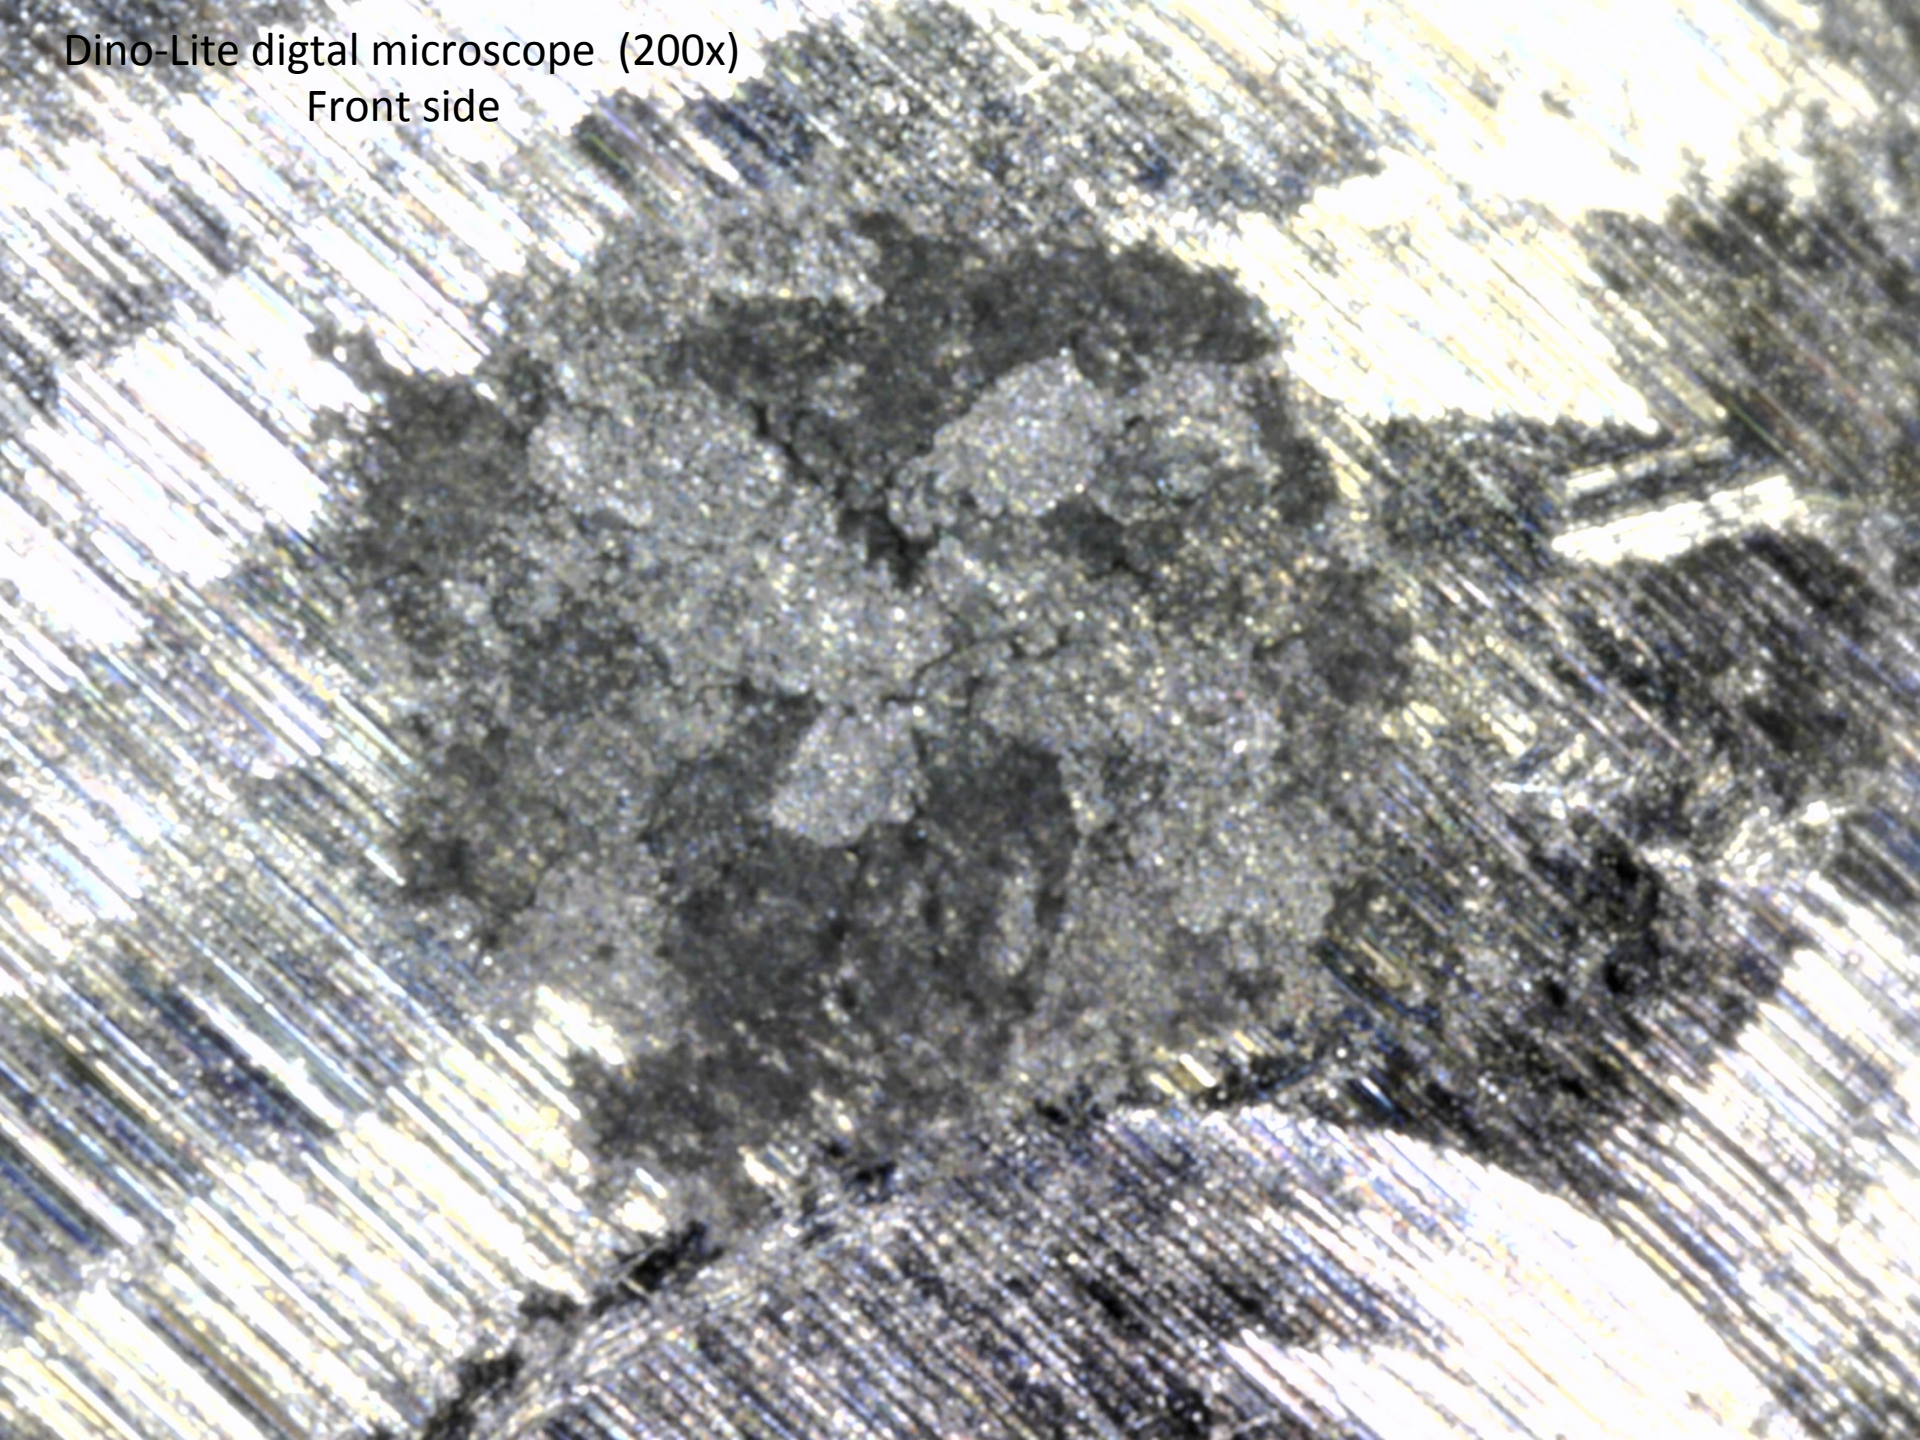
Front side

Dino-Lite digital microscope (200x)

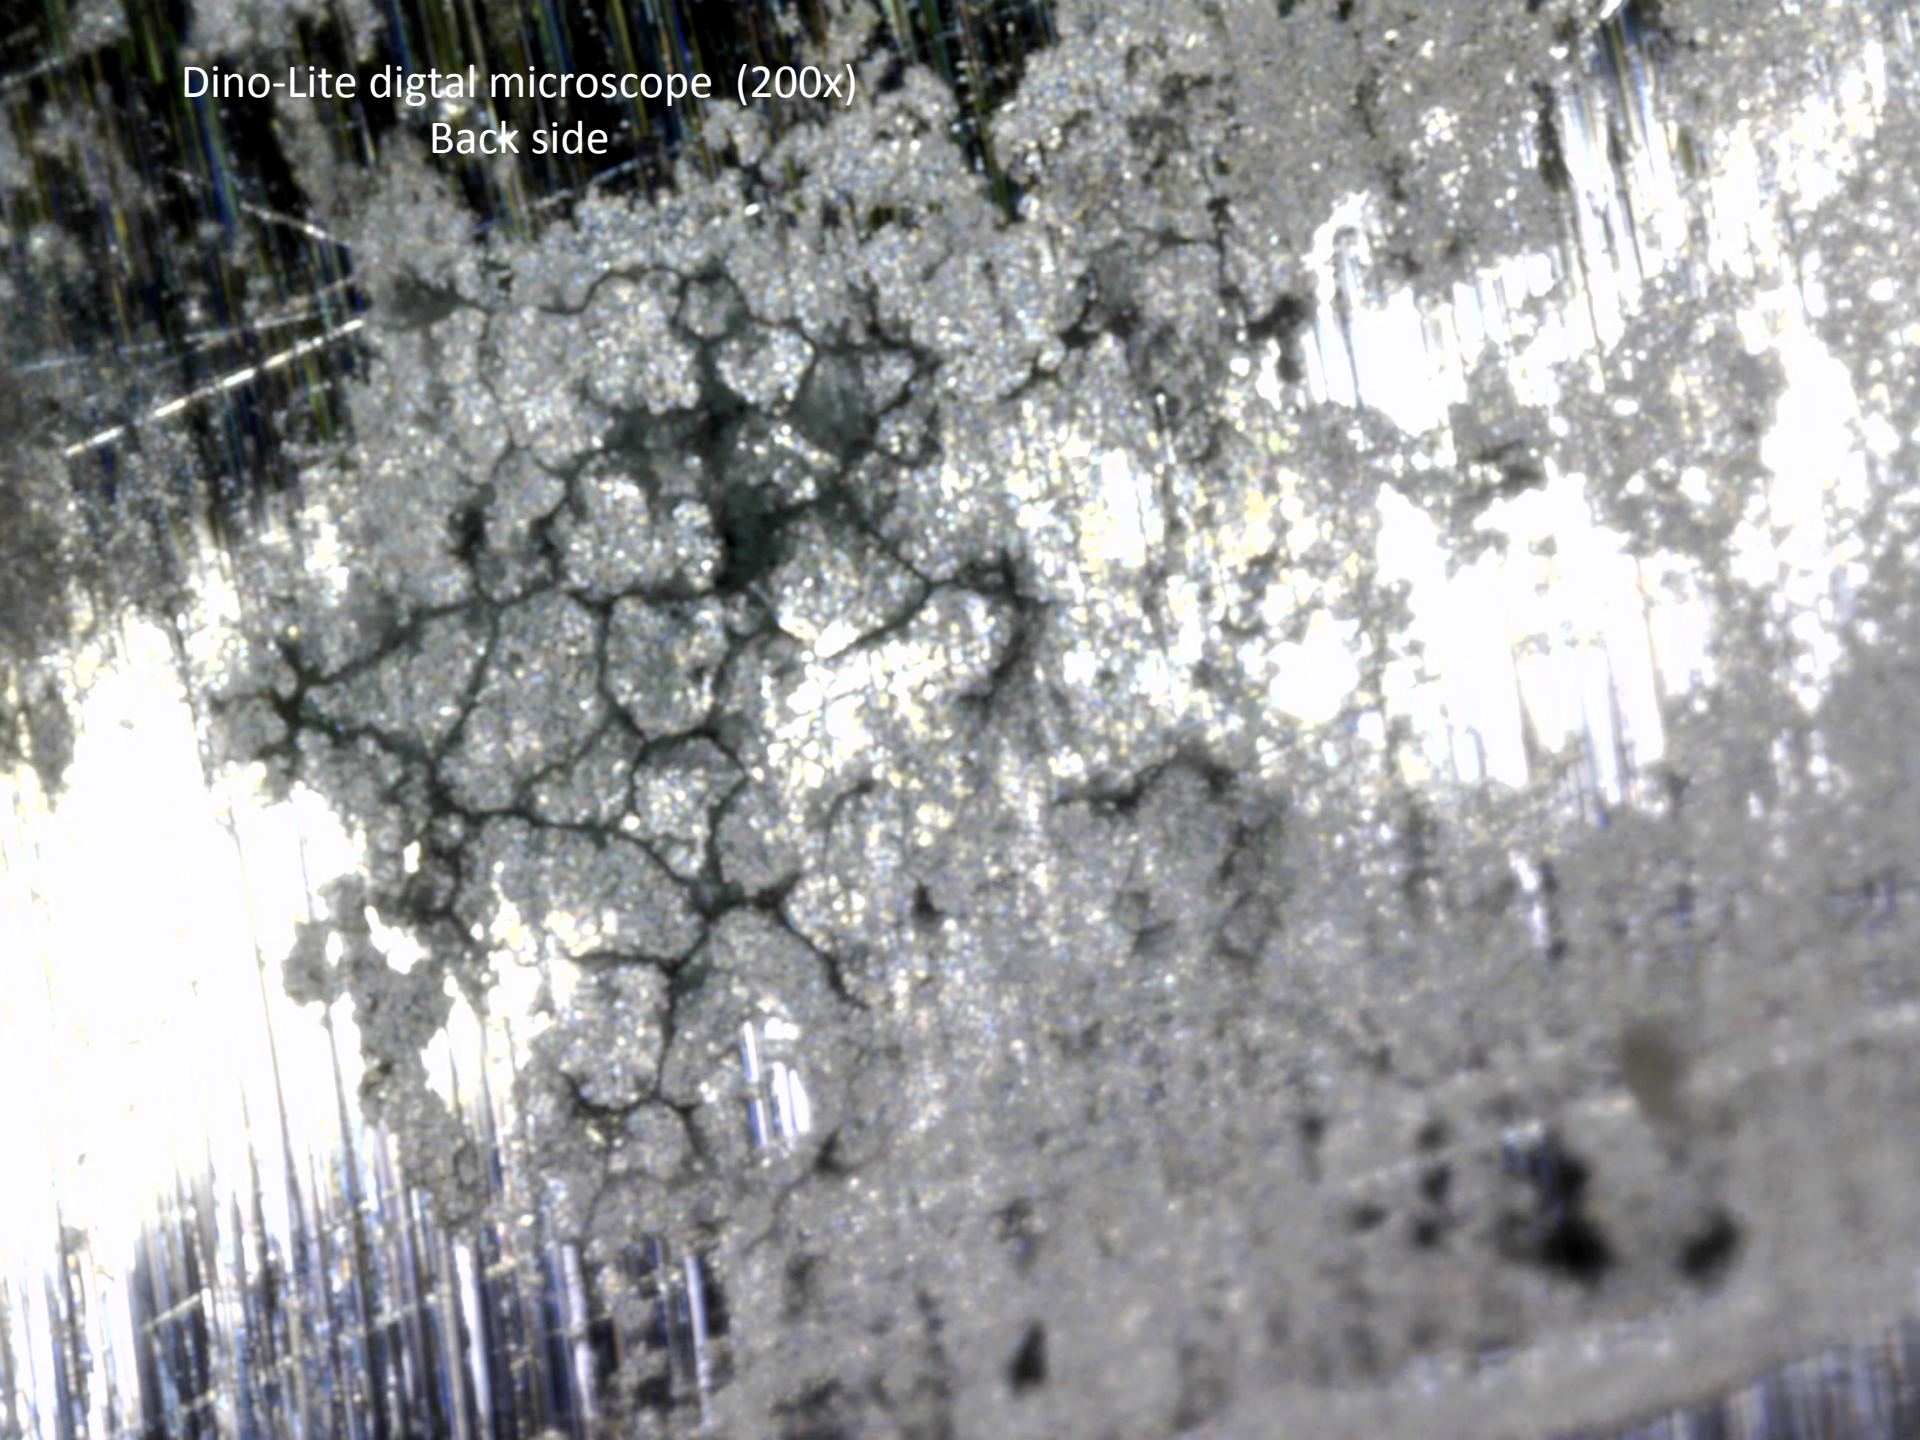
Dino-Lite digital microscope (200x)  
Back side

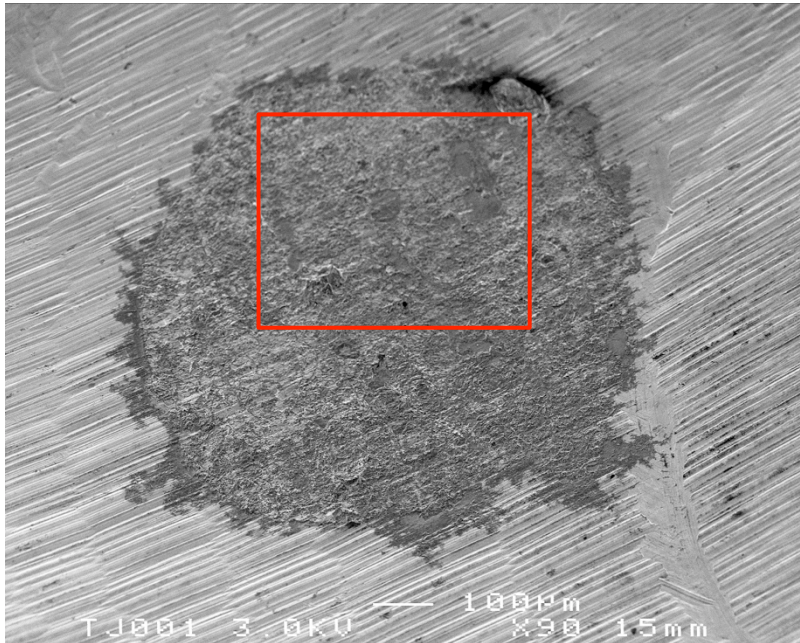
90x

# VU SEM pictures of leak spot

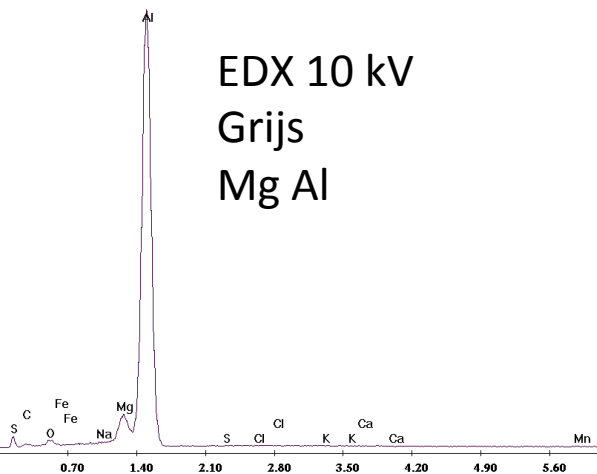
Label A: Tj. ketel Al folie op rondje lichtgrijs gebied, linksonder van lichte spot

- Area of 1 cm around leak is cut from the RF box.
- Leaky area of 1 mm diameter corresponds to a region with large grains that are also observed at the back of the foil.
- X-ray study shows AlMg<sub>3</sub> oxides in the leaky area, but also C, S and Cl.
- Some small regions (10 micron) also contain Fe, Mn and “Al without Mg” (surprise!).
- The 1 mm inclusion is maybe due to a cinder particle from an earlier melt in the same mold.

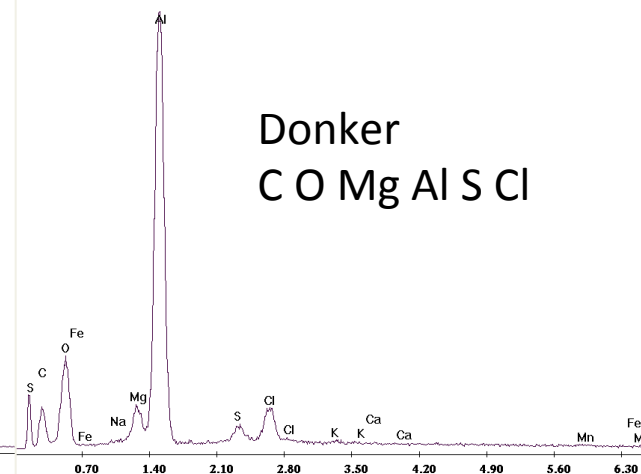
Label A: Tj. ketel Al folie op rondje donkergrijs gebied, rechts van lichte spot

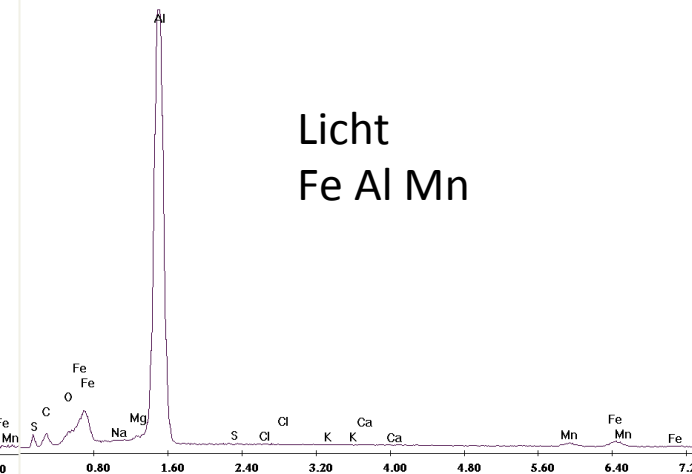
Label A: Tj. ketel Al folie op heldere punt Fe, Mn
