MEASUREMENTS

DISTANCE BETWEEN  
WHEEL RIM AND LOWER  
PETALS. END-CAP C

ITK-EC mechanics/integration engineers phone meeting

17 April 2024

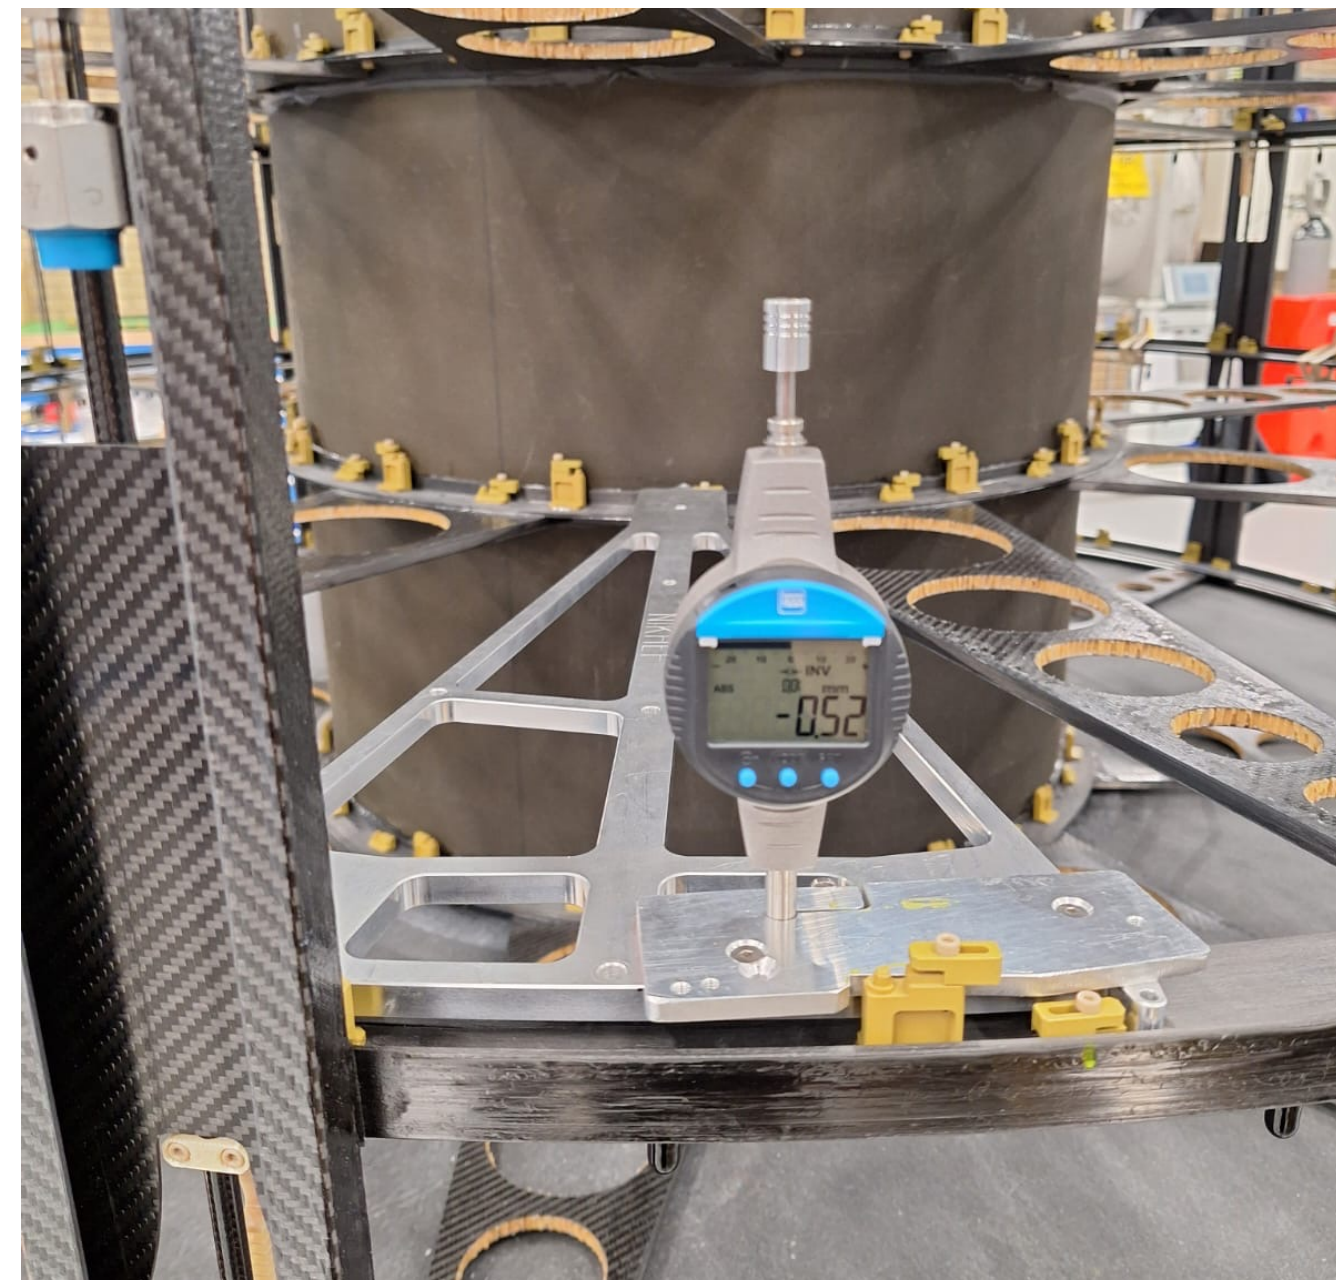
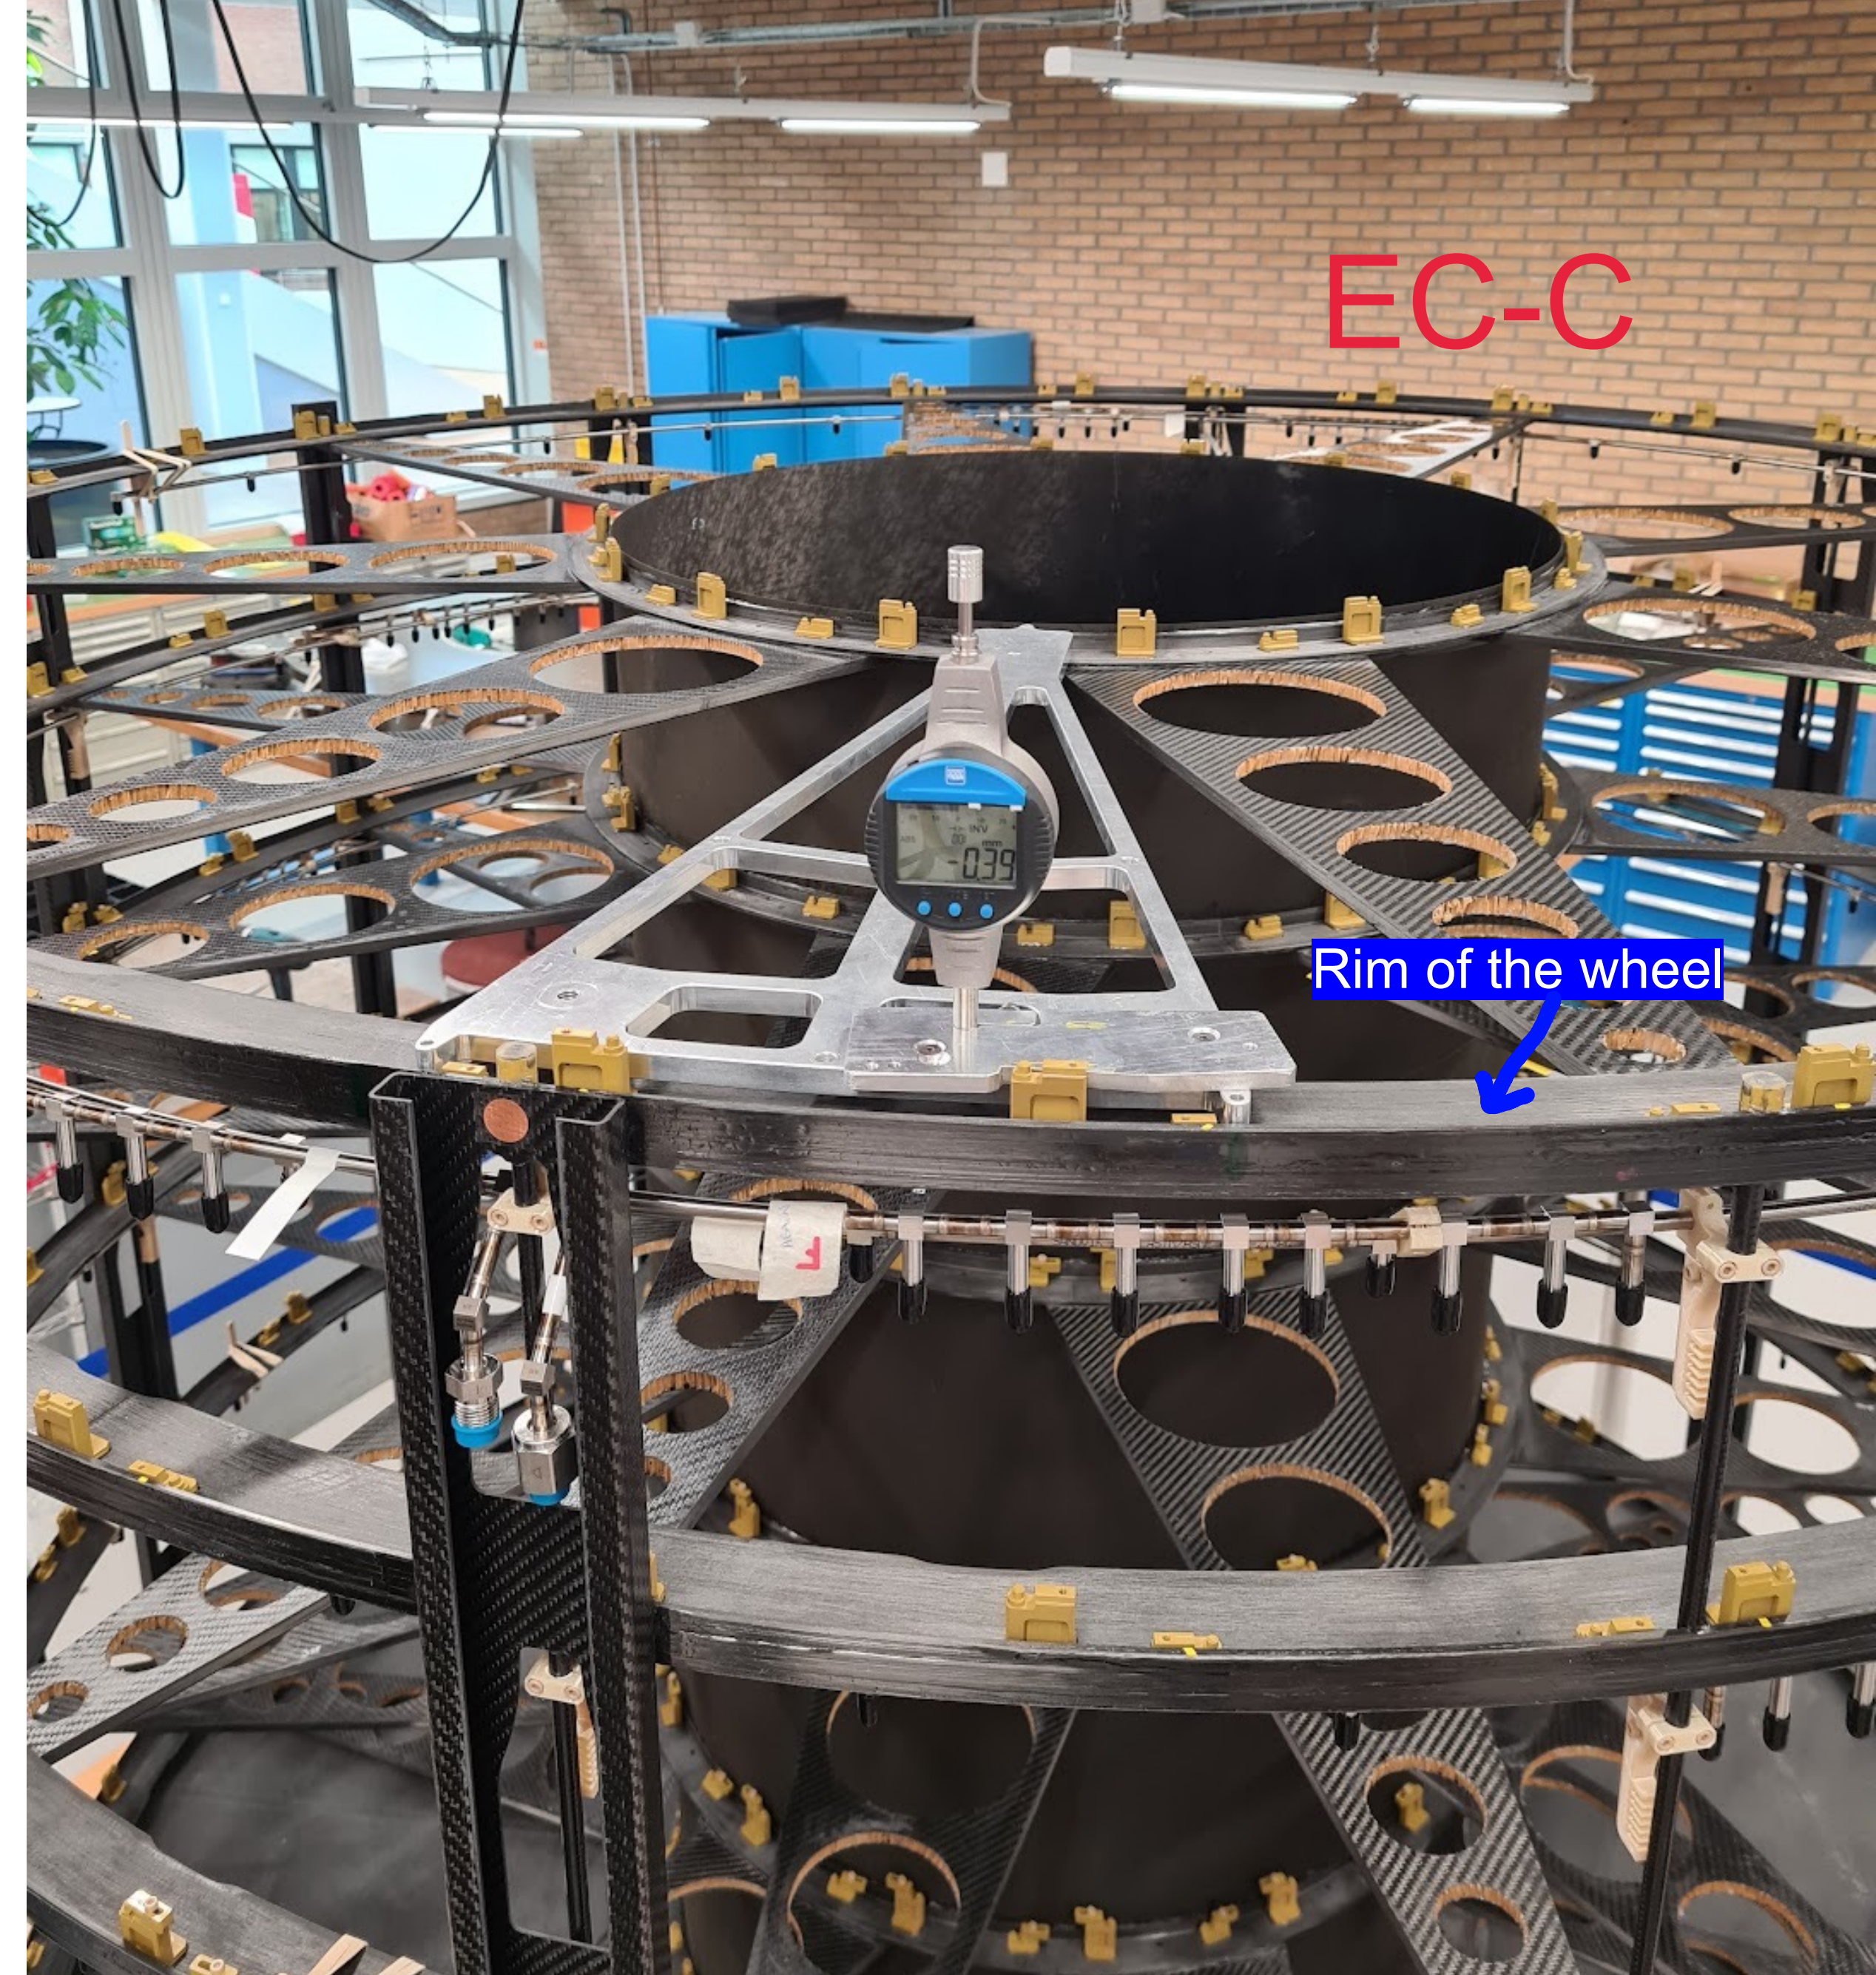
# SETUP: Petal + digital gauge

**Measurement:** Test petal is placed on low locking points. For this EC, we use a digital gauge with a needle touching the wheel rim.

**Nominal value: 0 mm.** This is the reference (0.0) respect to the 7mm-high low locking point (set by placing the petal on a custom plate with the nominal 7mm height).

**Petal for this test:** old petal that was used for the pipe bending frame. Added a plate with the gauge. The position for the height test is determined by the latest petal model.

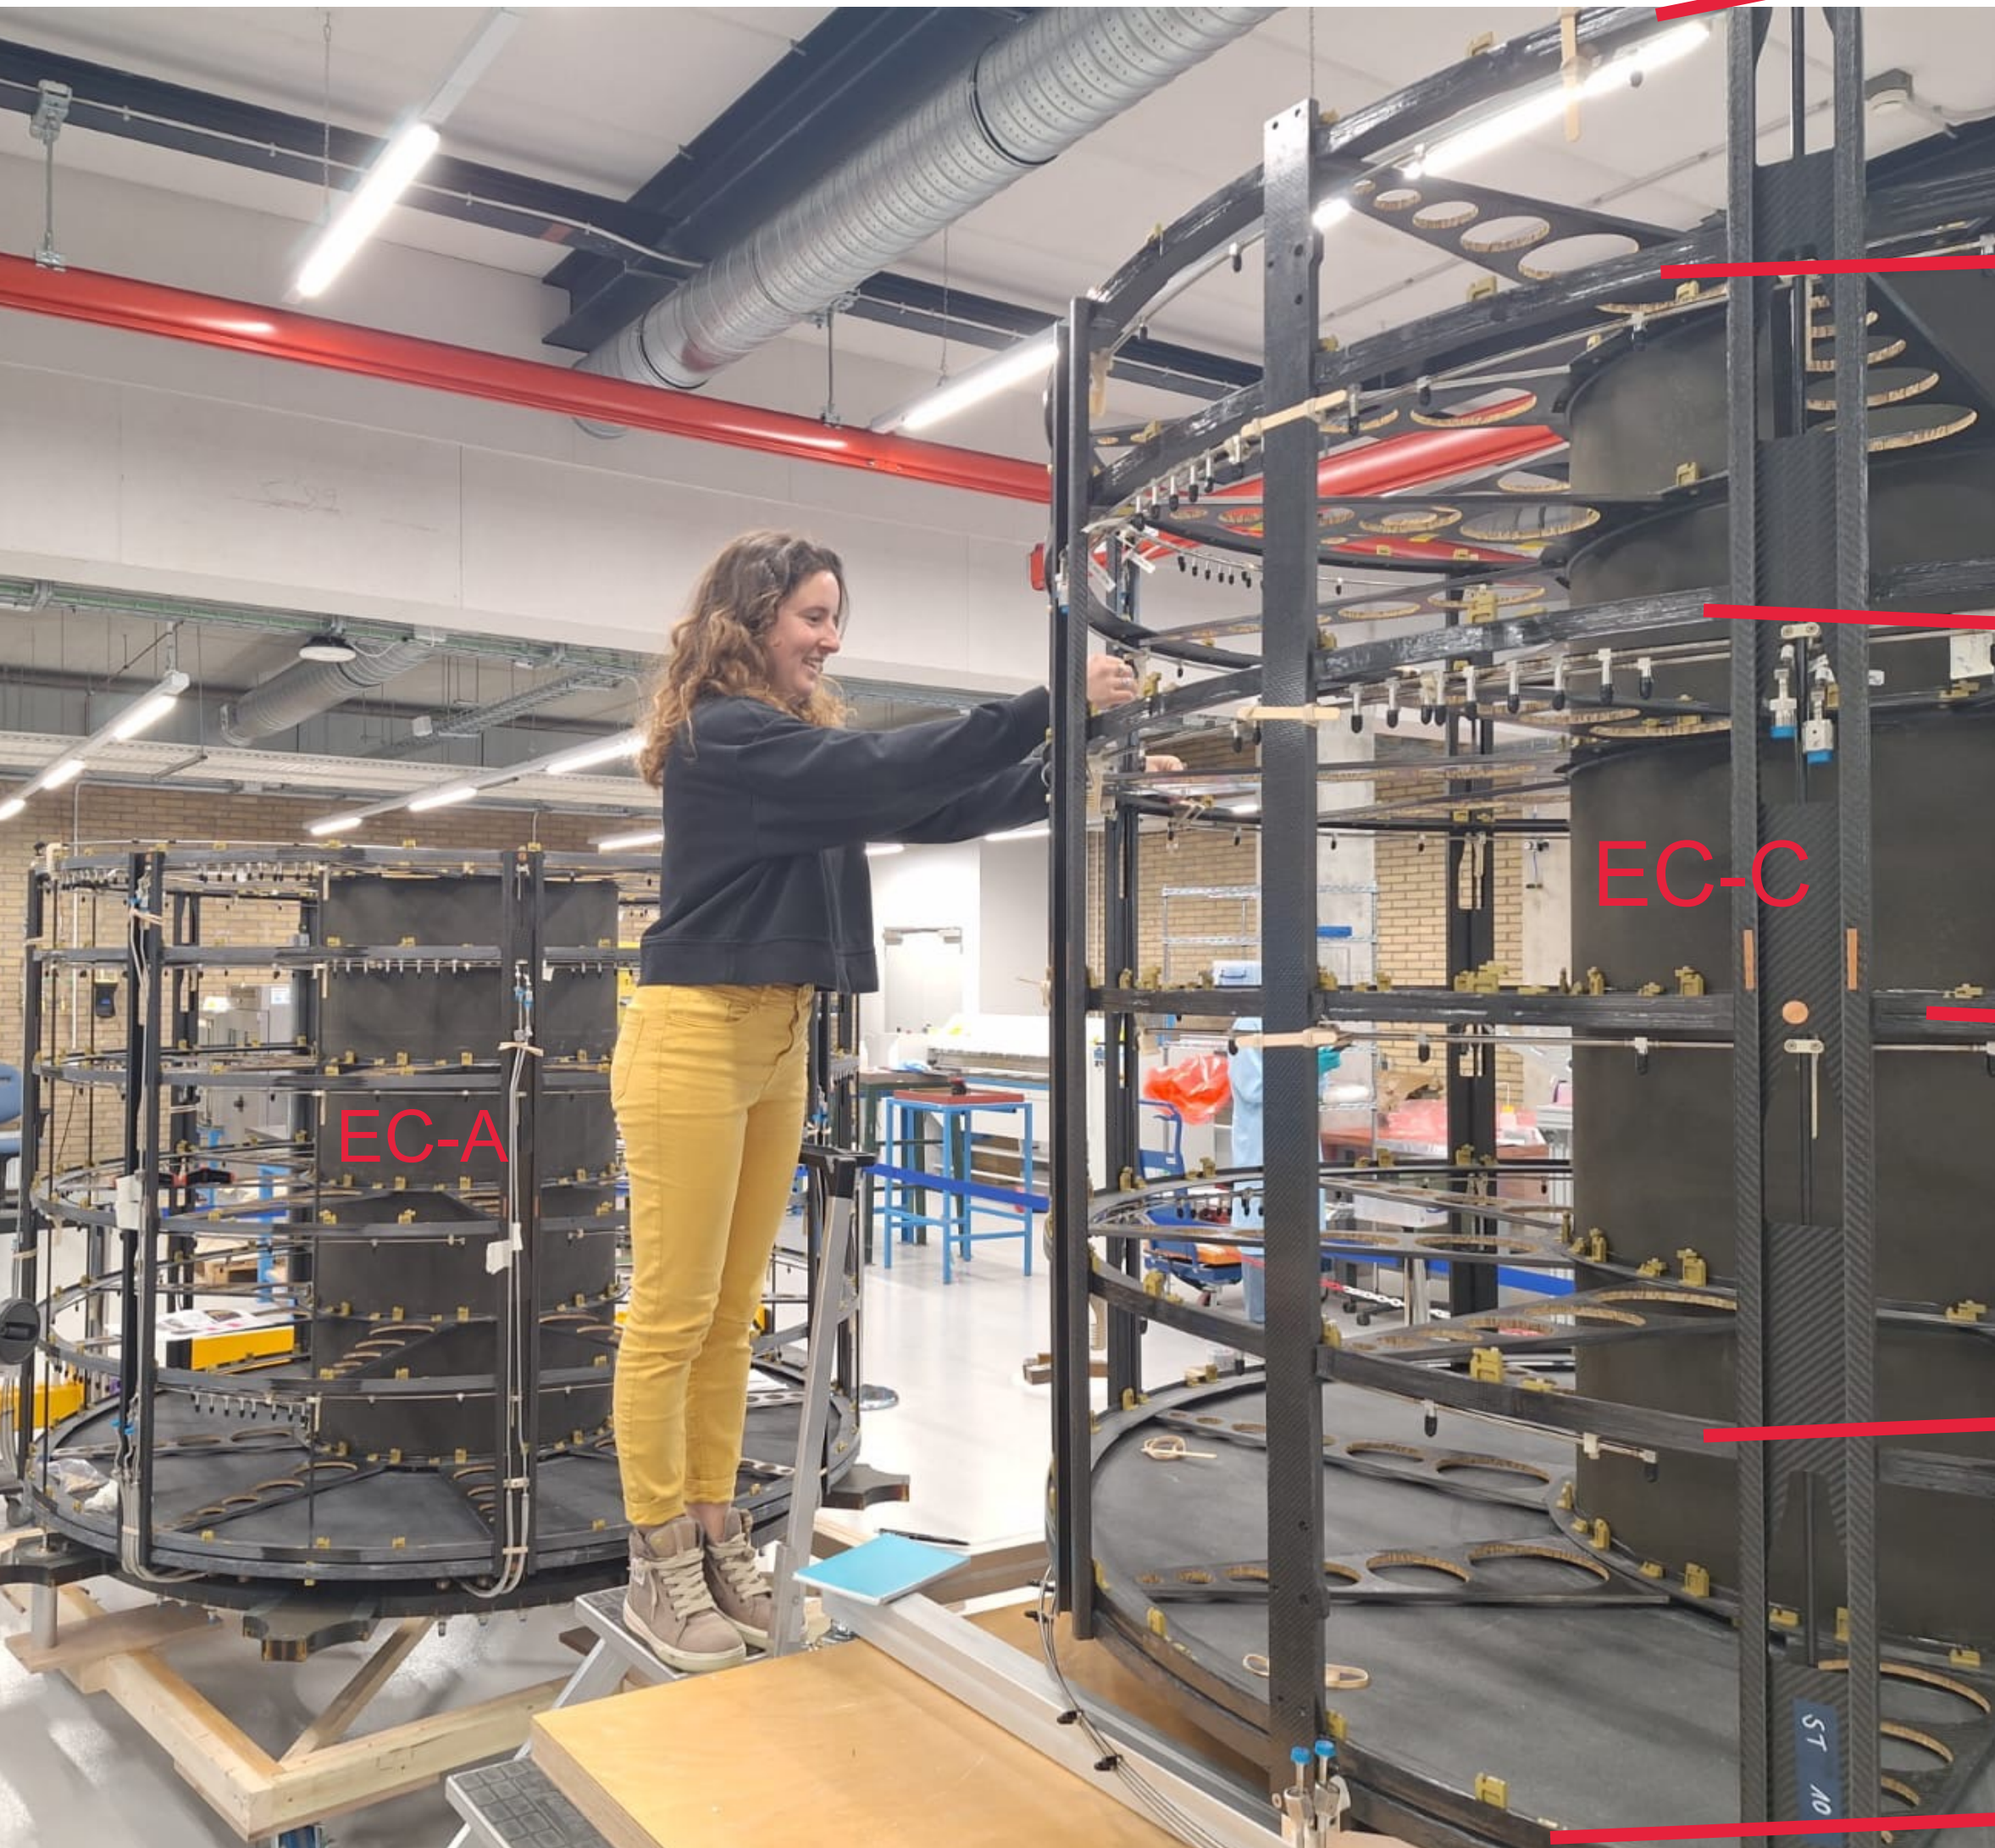
# EC-C. Measured distance between lower petals and wheel rim

deviation / mm

We measured a 7mm distance, with a deviation of  $\pm 300\mu\text{m}$ , between the wheel rim and the petals on the lower locking points.

This indicates consistent alignment across all wheels and the 16 measured locations per wheel.

However, out of the entire End-Cap, eleven positions were observed with distances smaller than 6.7mm. This raises concerns regarding potential issues if the petals exceed the expected thickness.

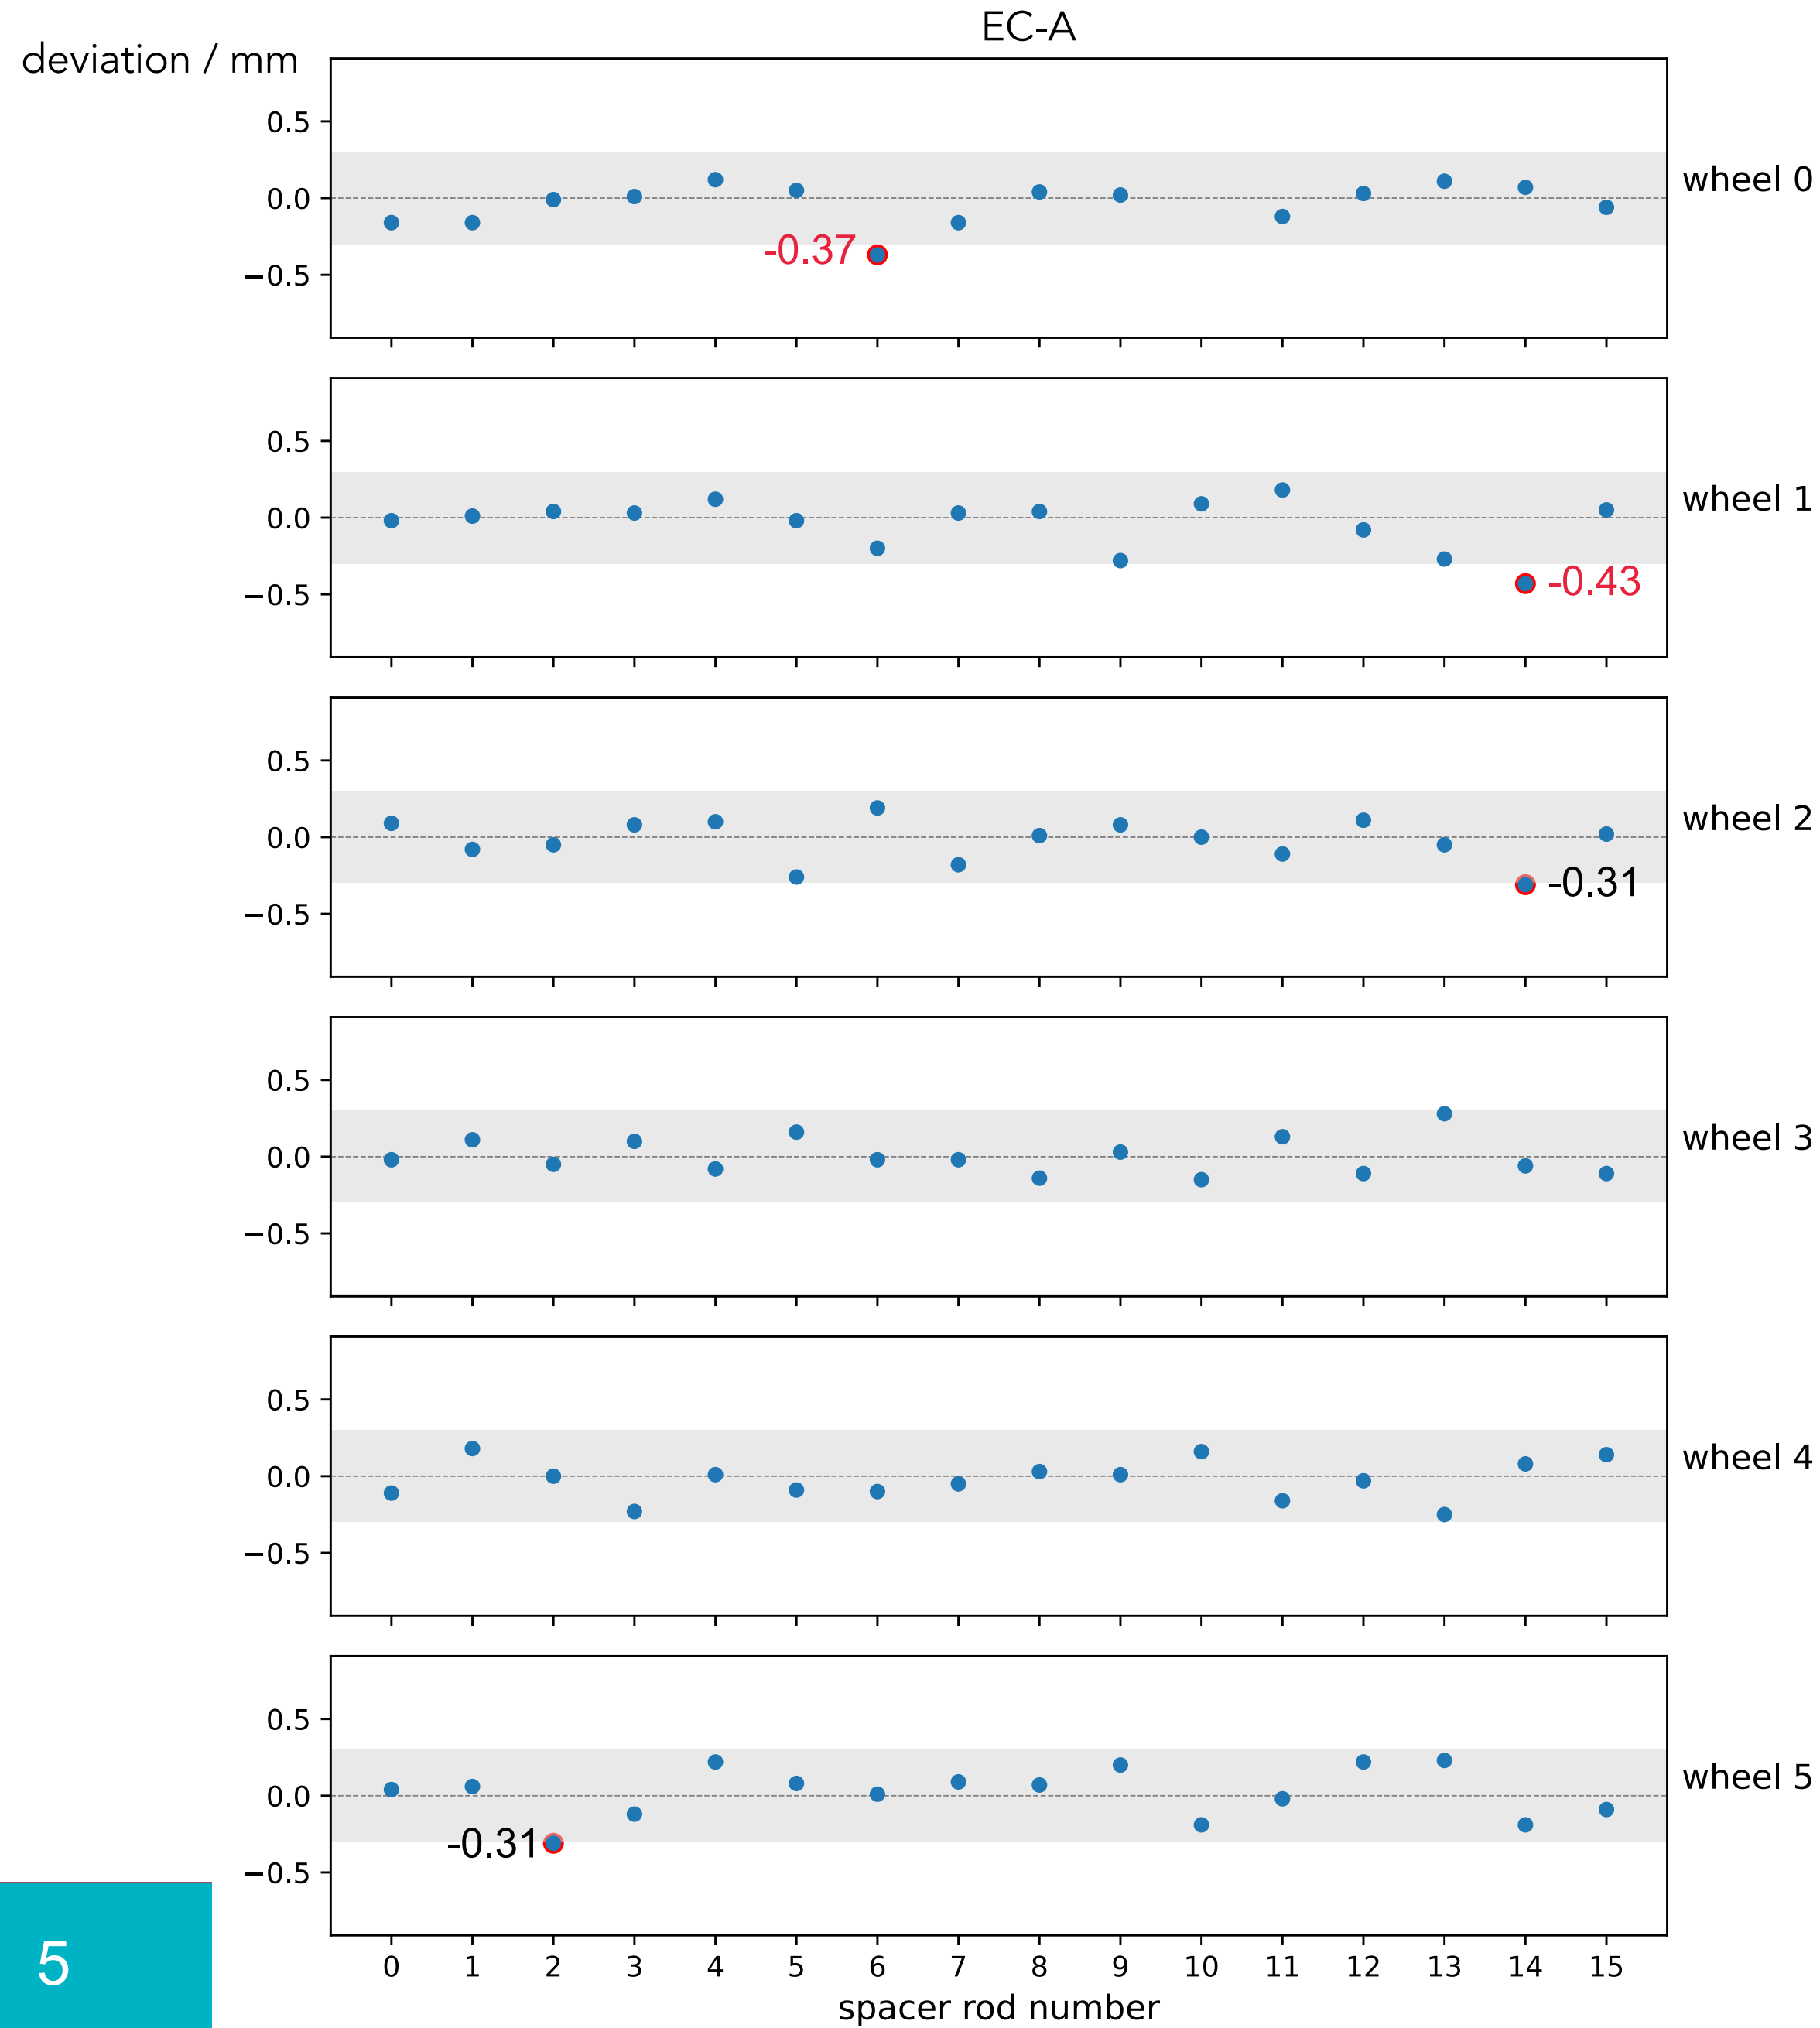
# Comparison between End-Caps

Note: spacer rod numbering corresponds to different spacer rods for each EC

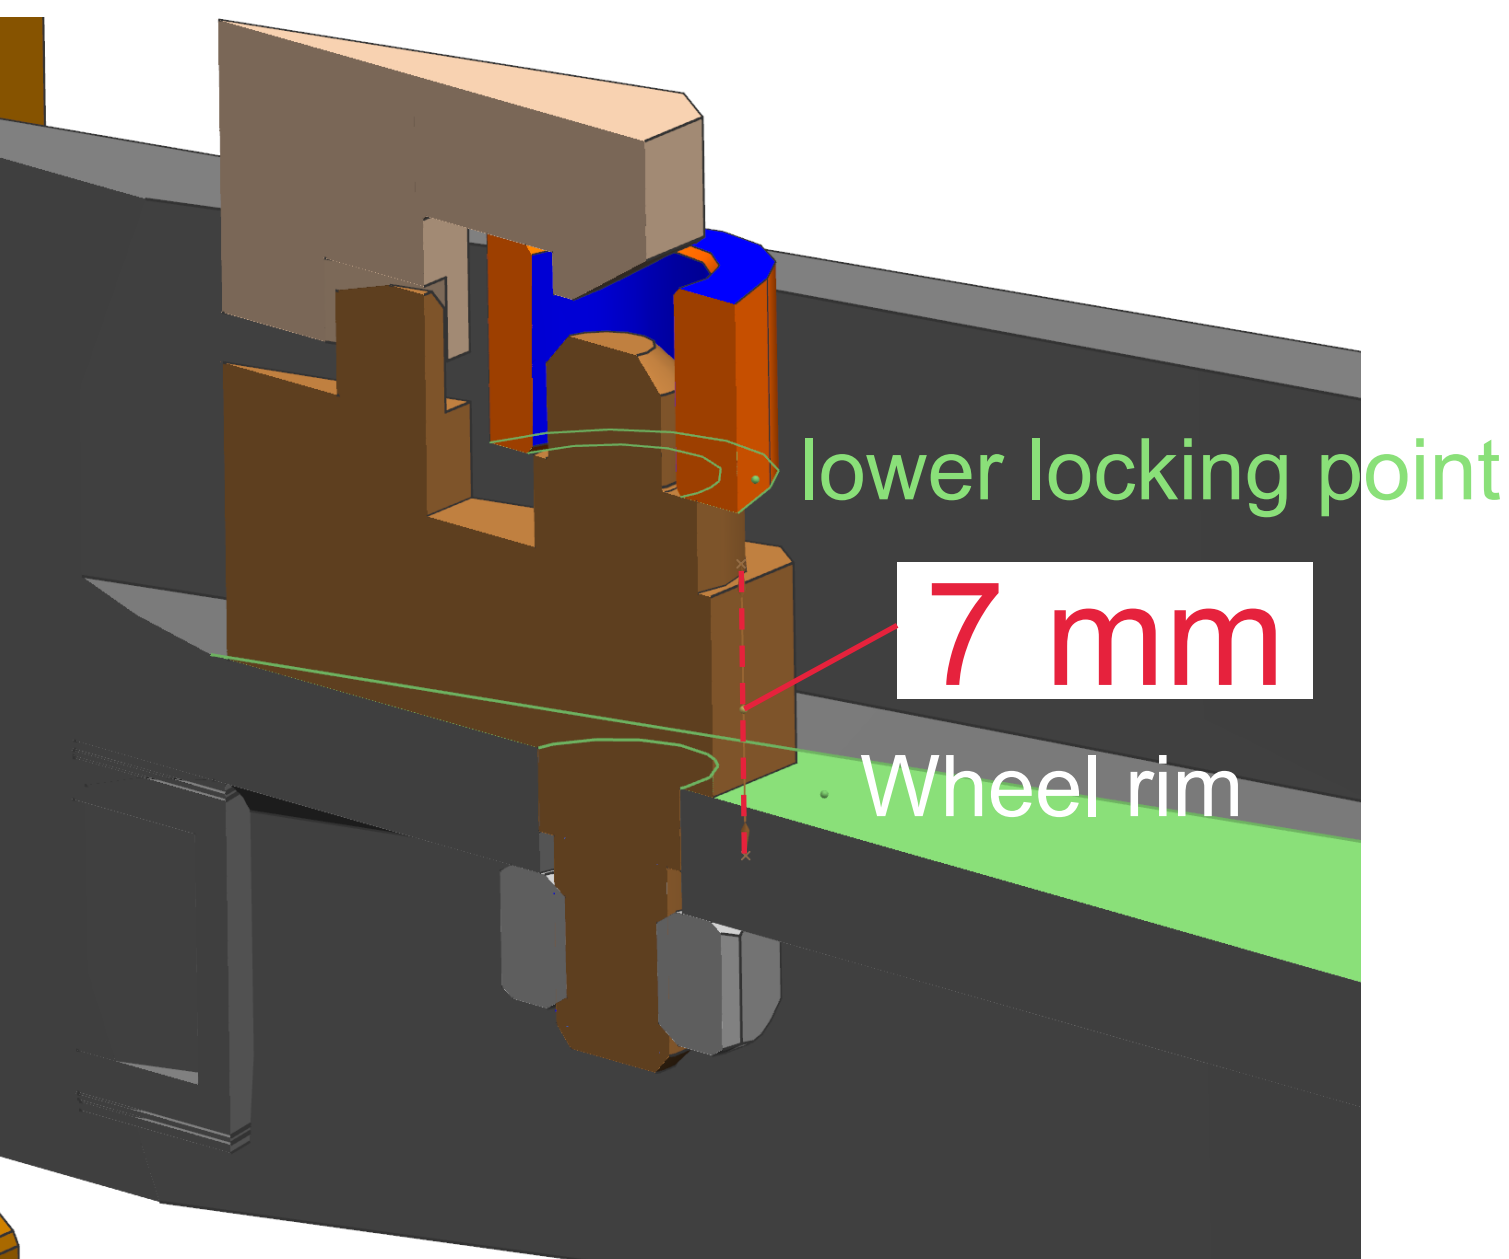
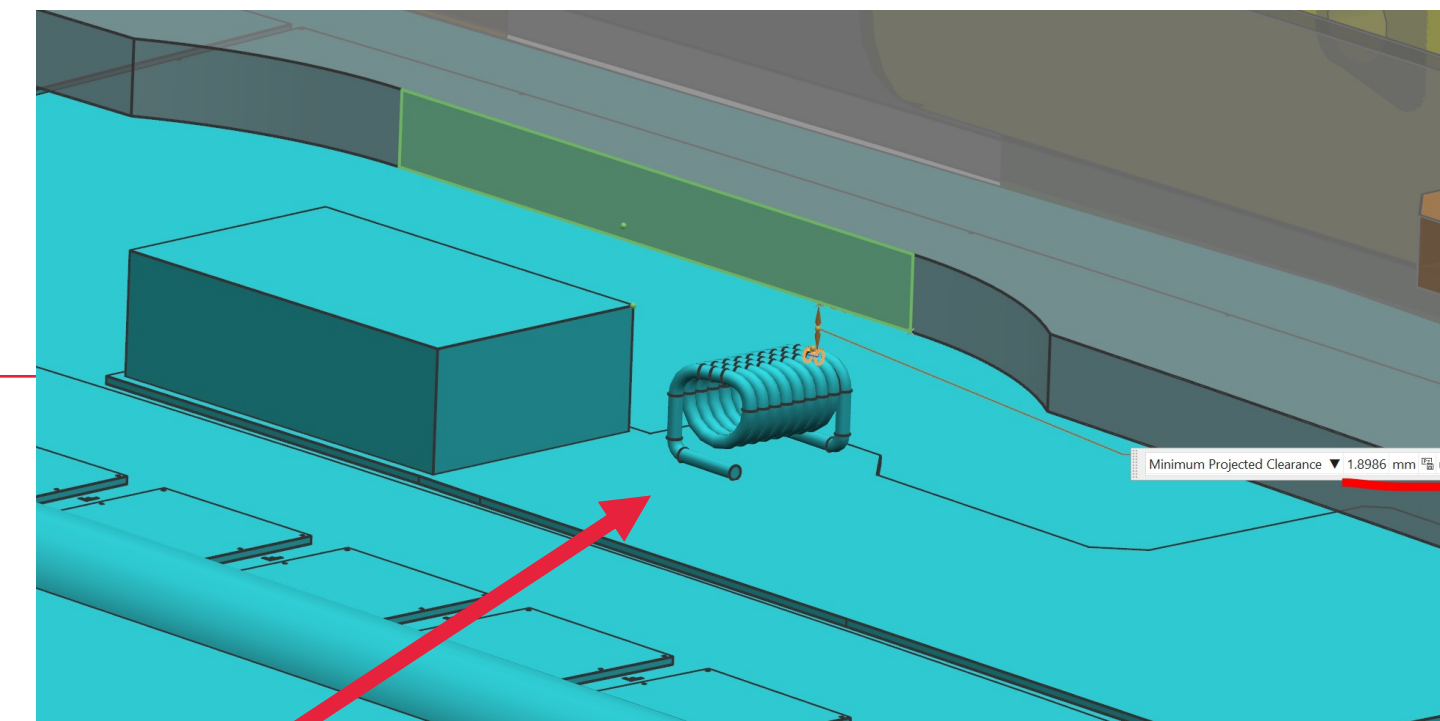
- w/o electronics: 7mm (-0.63mm at worst location)
- w/ electronics:

- ☞ Due to coil on the powerboard, near the RF box: Vertical clearance 1.9mm  $\Rightarrow$  not critical
- ☞ If interposer added under the powerboard. How much clearance would it take away? -0.5mm?
- ☞ If RF5 box moves  $\Rightarrow$  critical

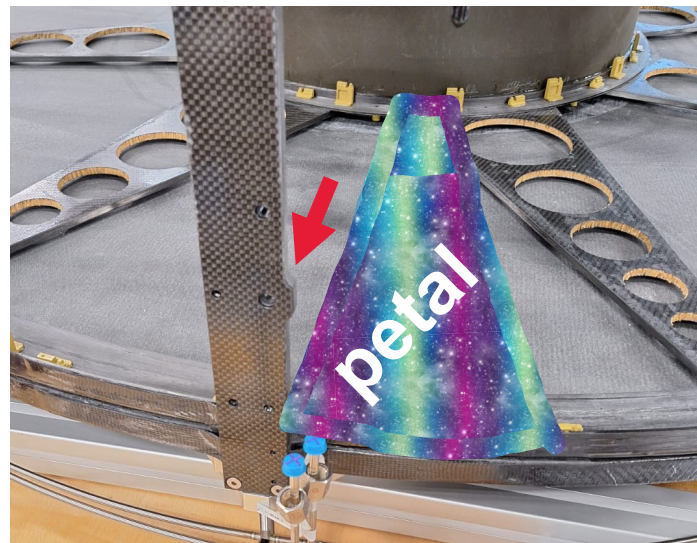
Spacer rod 0 is the one inside the beamer with the **external edge**. We followed clock-wise direction around inner cylinder.
