# Photos of leak in milled Al-foil; $1.1 \cdot 10^{-6}$ mbar l/s

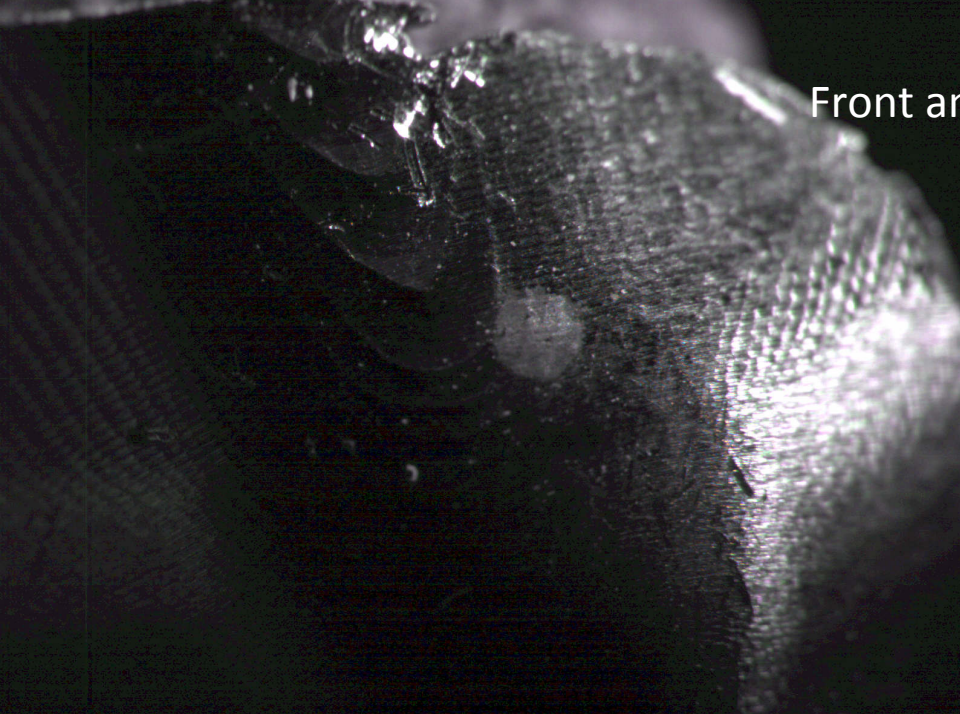
Olympus Microscope ET  
DinoLite Webcam  
Scanning electron microscope  
(SEM+EDX at VU)

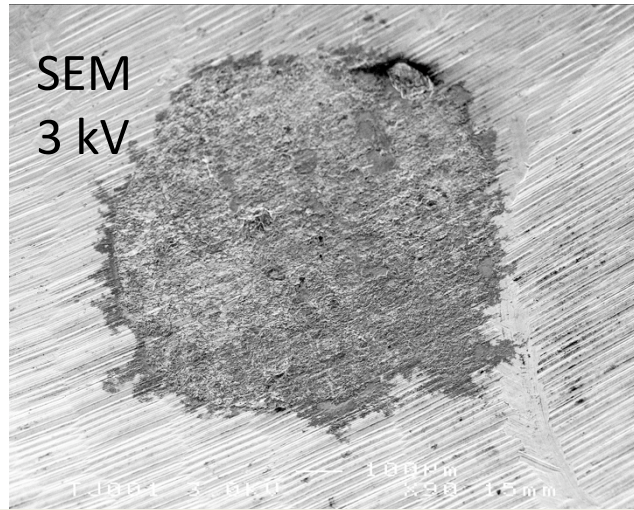
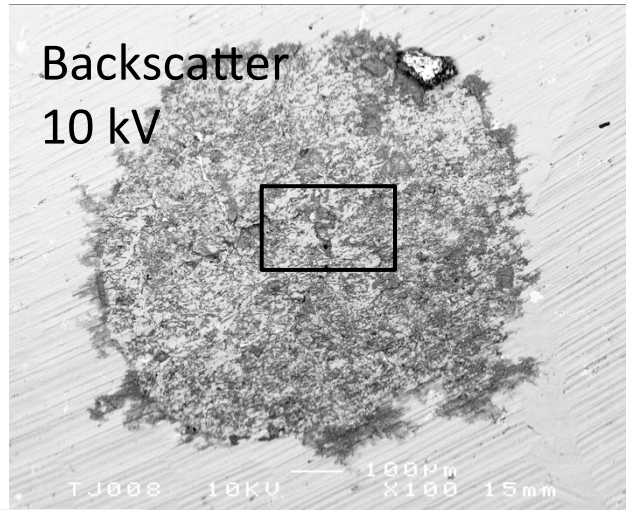
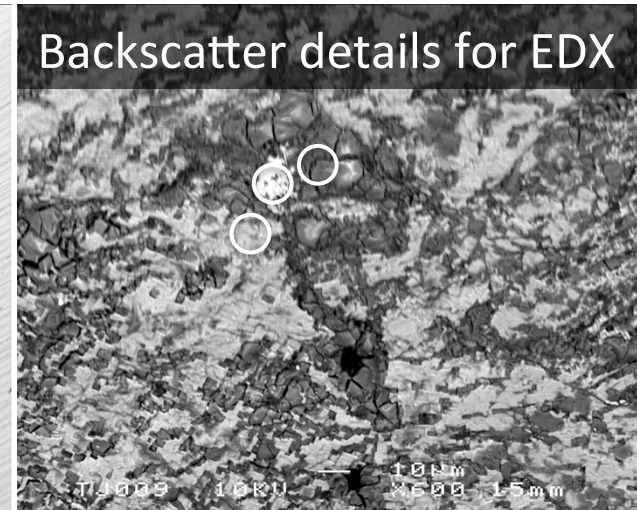
SEM  
3 kV

Backscatter  
10 kV

Backscatter details for EDX

- Area of 1 cm around leak is cut from the RF box.
- Leaky area of 1 mm diameter corresponds to a region with large grains that are also observed at the back of the foil.
- X-ray study shows AlMg<sub>3</sub> oxides in the leaky area, but also C, S and Cl.
- Some small regions (10 micron) also contain Fe, Mn and “Al without Mg” (surprise!).
- The 1 mm inclusion is maybe due to a cinder particle from an earlier melt in the same mold.
