# 15<sup>th</sup> fToA bin

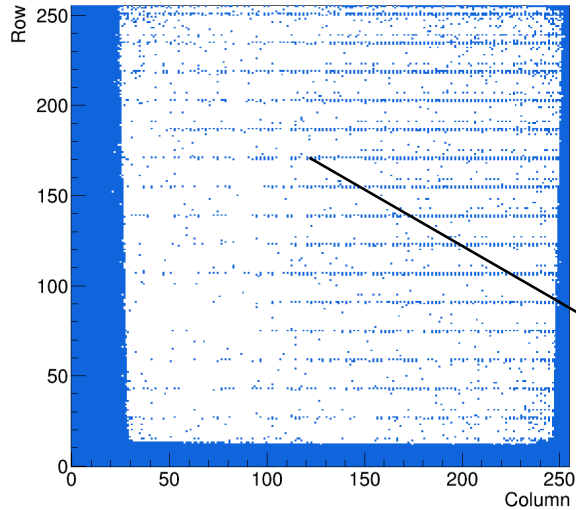
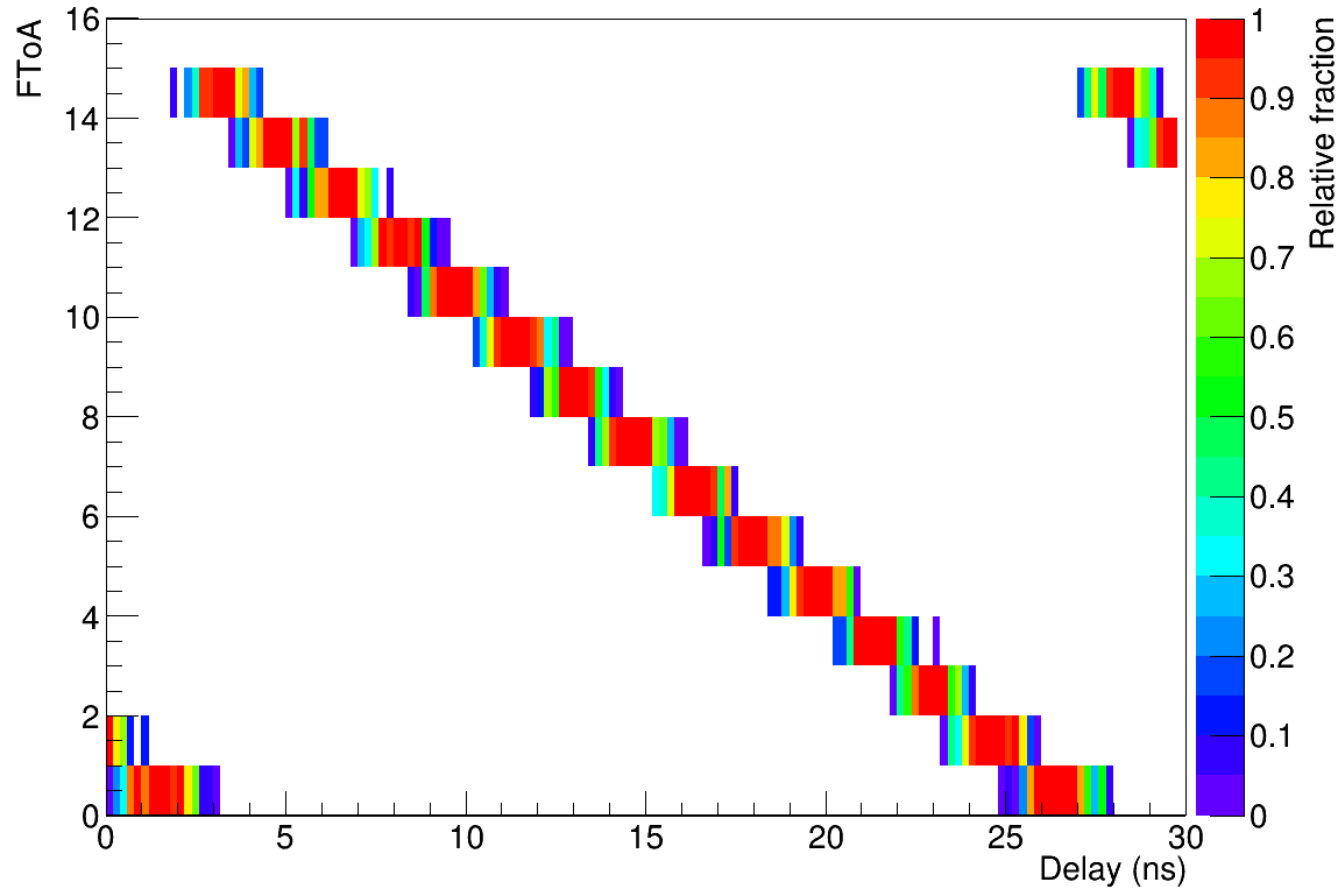
No noticeable change in length of bin 0, thus indicating a change in the control voltage as the culprit for not filling bin 15

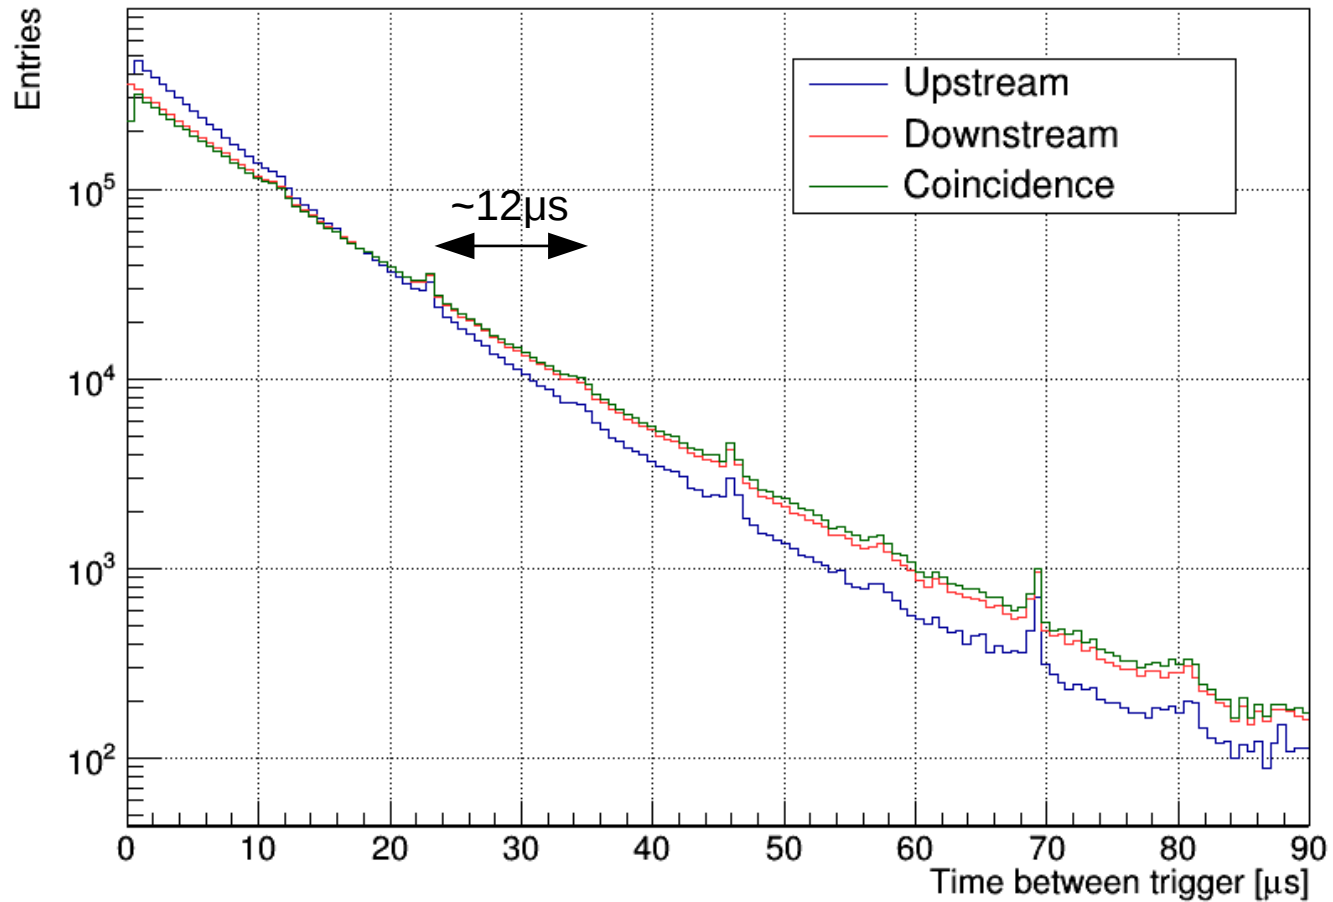
# Triggers from testbeam

There seems to be an increase in triggers at an integer number times 83kHz?
